OSPREY HOME INSPECTIONS

Inspection Report

Property Address:
34 Sample Street

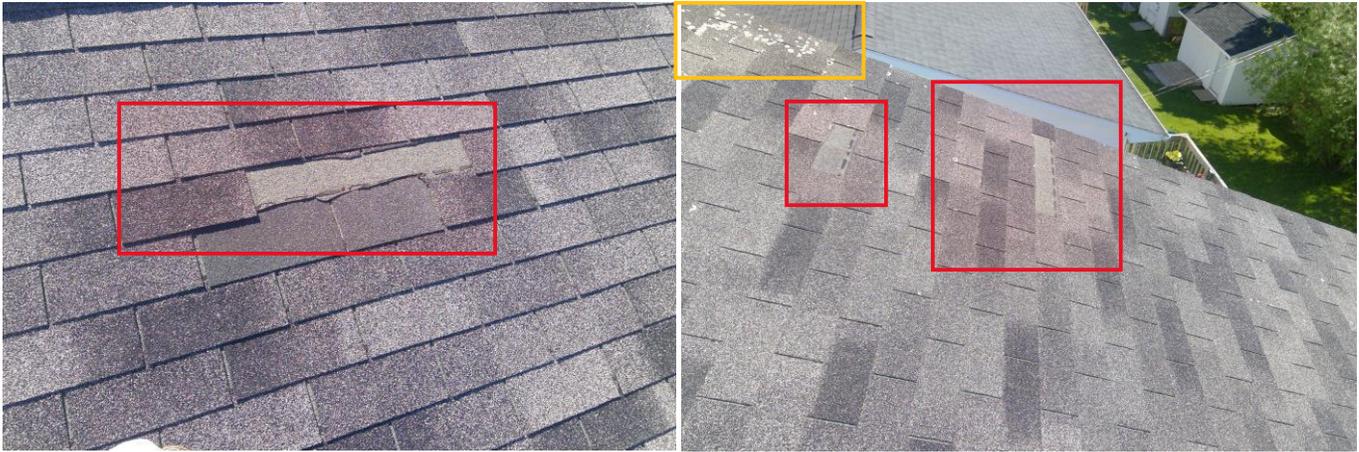
C. Roof Covering Materials

Comments: Missing shingles in some areas, I recommend further evaluation and repair by licensed roofing contractor.

Areas of the asphalt roof had lichen growing on it. This condition indicates high moisture levels. Lichen are slow growing and do not damage roofing materials, but are a cosmetic issue. Efforts at removal are likely to remove granules, exposing the underlying asphalt to damaging UV radiation from sunlight. Lichens are better left in place. They are a cosmetic issue only.

Inspector found a few missing tabs/shingles upon walking the roof. Inspector recommends correction by licensed roofing contractor

C. Inspector found a few missing tabs/shingles upon walking the roof. Inspector recommends correction by licensed roofing contractor.

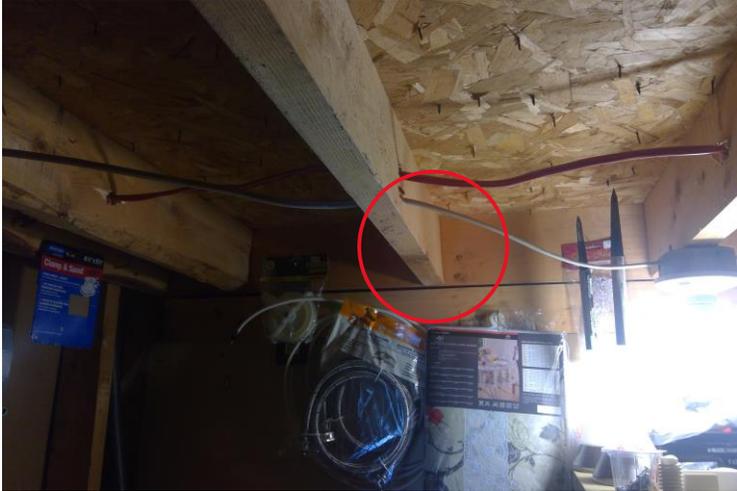
F. Ceiling and Floors

Comments: Front entry landing isn't supported by joist hangers. Inspector recommends correction by licensed contractor.

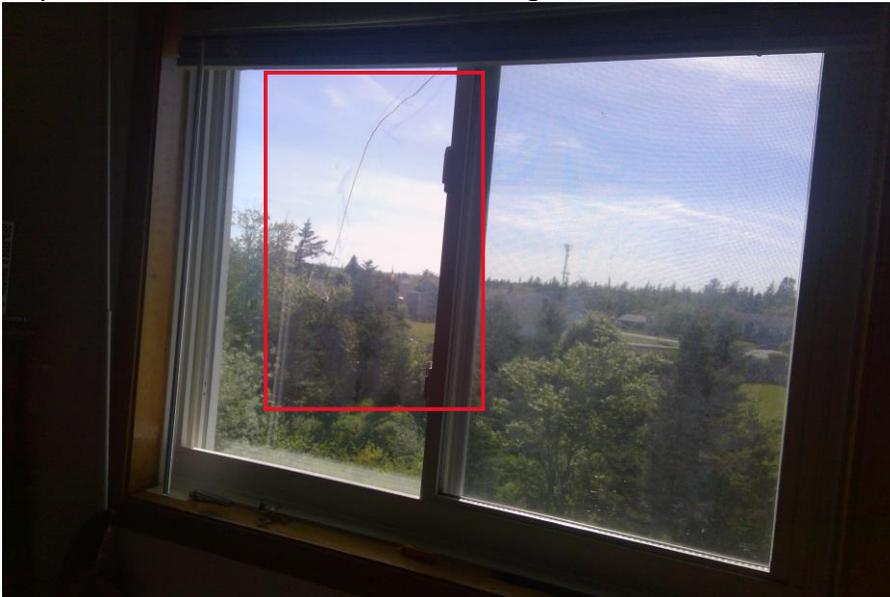
H. Windows

Comments: Third bedroom window had a crack in the glass, Inspector recommends replacement by licensed contractor. Many of the windows in the home were "sticky", Inspector recommends annual lubricating of window slides.

H. Third bedroom window had a crack in the glass, Inspector recommends replacement by licensed contractor. Many of the windows in the home were “sticky”, Inspector recommends annual lubricating of window slides

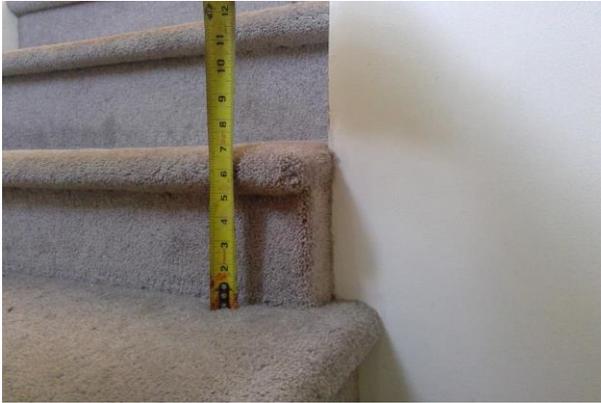
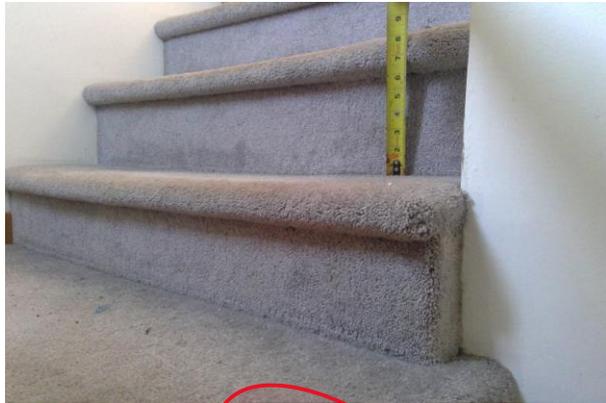
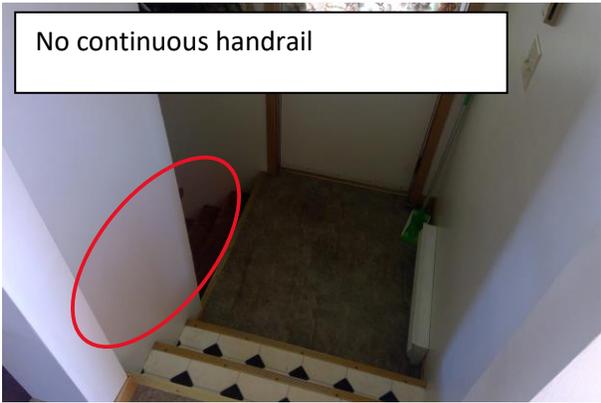
I. Stairways (interior and Exterior)

Comments: Top-level stairs had inconsistent rises. Basement stairs handrail doesn't clear the bottom few steps. Both stairways need a continuous handrail from top to bottom of stairs. Inspector recommends a continuous rail be installed on both sets by licensed contractor.

No continuous handrail

I. Top-level stairs had inconsistent rises. Basement stairs handrail doesn’t clear the bottom few steps. Both stairways need a continuous handrail from top to bottom of stairs. Inspector recommends a continuous rail be installed on both sets by licensed contractor.

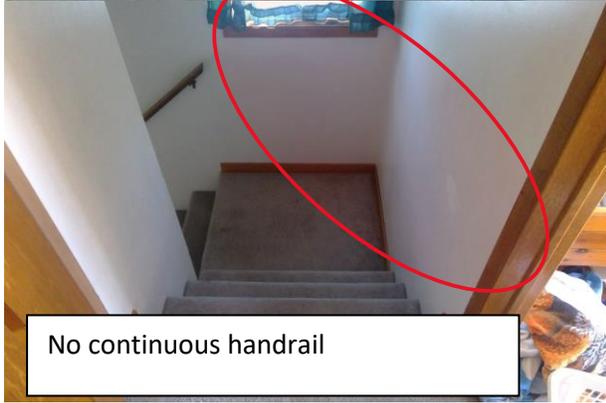
No continuous handrail

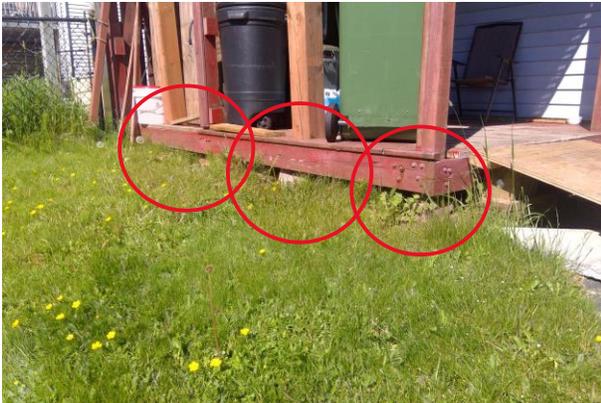
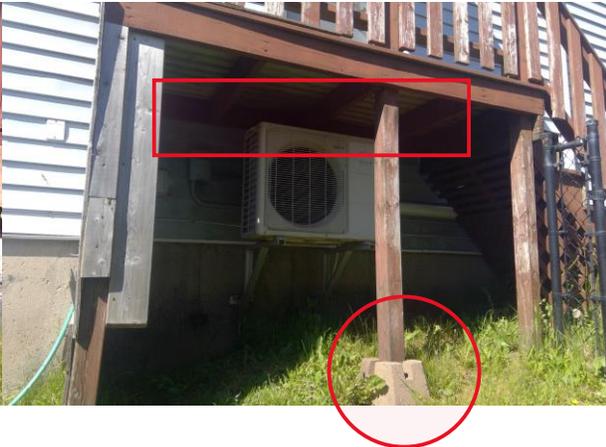
K. Balconies, Decks, Porches, Carports

Comments: Back deck was supported by deck blocks, this condition is substandard for a deck of this height. It needs to be supported by concrete piles that extend below the frostline (48"). Side entry deck was supported by deck blocks, This condition is substandard when the deck is attached to the house. Side entry deck also needs joist hangers to be installed. Inspector recommends all work to be conducted by licensed contractor.

K. Back deck was supported by deck blocks, this condition is substandard for a deck of this height. It needs to be supported by concrete piles that extend below the frostline (48”). Side entry deck was supported by deck blocks, This condition is substandard when the deck is attached to the house. Side entry deck also needs joist hangers to be installed. Inspector recommends all work to be conducted by licensed contractor.

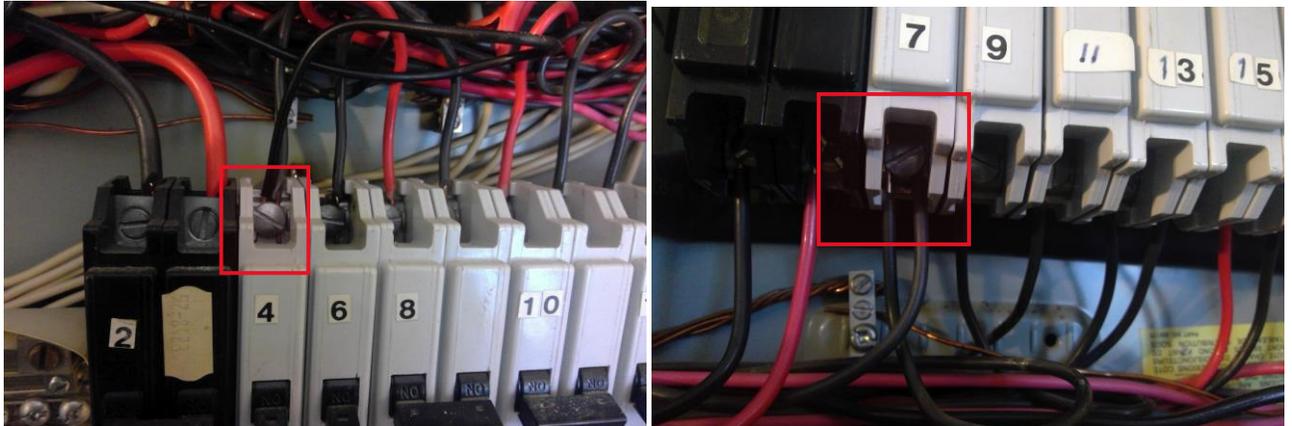
A. Service Entrance and Panels

Comments: The panel was mostly OK. Inspector found 2 breakers that had more than one connection or “double-tapped” at time of inspection. Panel should be clearly labelled with a legend. Some rust spots at bottom of the panel. Although these conditions are consistent with houses built around the same time, these conditions are below standard and the inspector recommends further evaluation and correction by a licensed electrical contractor.

A. The panel was mostly OK. Inspector found 2 breakers that had more than one connection or “double-tapped” at time of inspection. Panel should be clearly labelled with a legend. Some rust spots at bottom of the panel. Although these conditions are consistent with houses built around the same time, these conditions are below standard and the inspector recommends further evaluation and correction by a licensed electrical contractor.

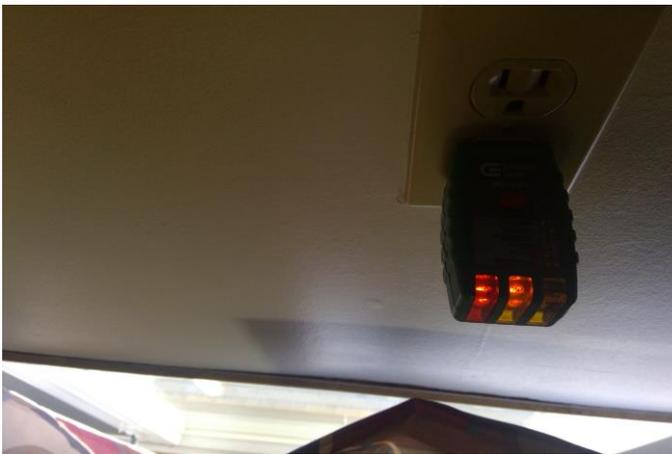
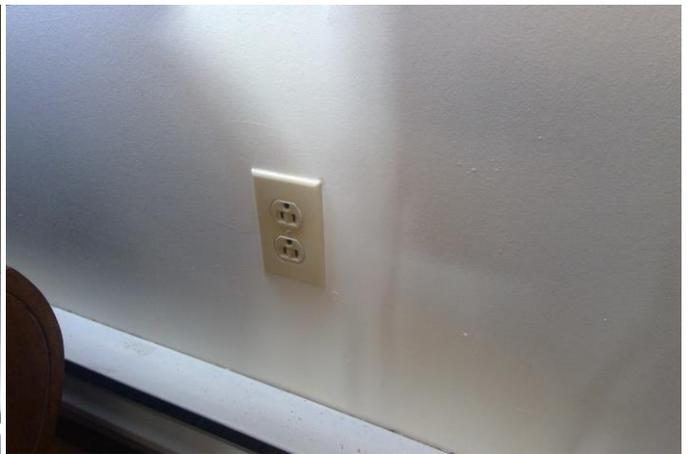
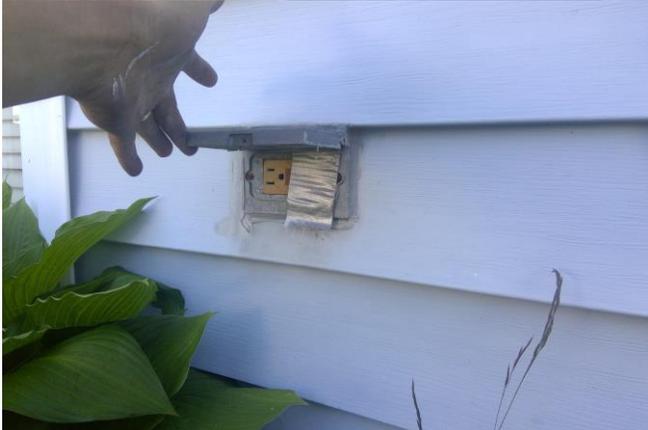
B. Branch Circuits, Connected Devices and Fixtures

Comments: No arc-fault circuit interrupter (AFCI) protection was installed to protect electrical circuits in bedrooms. Safety standards after 2015 state new homes must comply require the installation of AFCI protection of all bedroom electrical receptacles. Although AFCI protection was not

required at the time the home was originally constructed, as general knowledge of safe building practices has improved with the passage of time, building standards have changed to reflect current understanding. The Inspector recommends updating the existing bedroom receptacles to provide AFCI protection.

No ground fault circuit interrupter (GFCI) protection of electrical receptacles was provided in the kitchen. Although GFCI protection may not have been required at the time the home was built, for safety reasons, the Inspector recommends that the home electrical system be upgraded to meet modern safety standards. All work should be performed by a qualified electrical contractor.

The receptacle in living room above baseboard heater had hot and neutral reversed. This may present a safety hazard so anyone who uses it. Inspector recommends correction by licensed electrical contractor

Outside receptacle is broken at front of home. Inspector recommends correction by licensed electrical contractor.

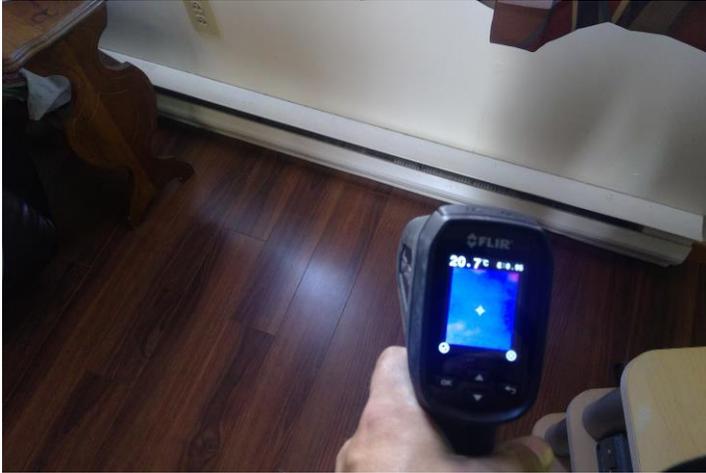
A. Heating Equipment

Comments: Baseboard radiator didn't turn on at the time of inspection, inspector recommends further evaluation and correction by licensed electrical contractor

A. Baseboard radiator didn't turn on at the time of inspection, inspector recommends further evaluation and correction by licensed electrical contractor.

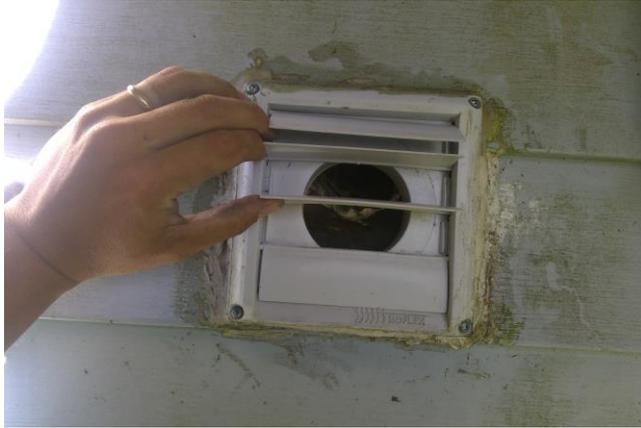
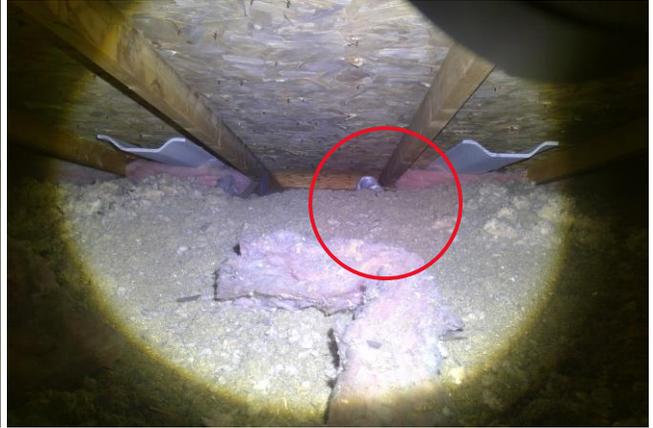
C. Duct System, Chases, and Vents

Comments: basement bathroom vent doesn't line up with vent pipe, this may affect the operation of vent blower.

Primary bathroom fan vents into the soffit. This condition is substandard and may lead to increased presence of moisture in attic, which may lead to microbial growth. Inspector recommends an appropriate vent be installed by licensed contractor.

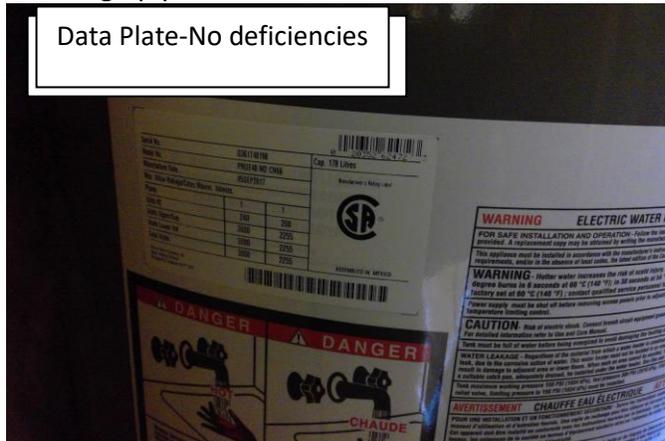
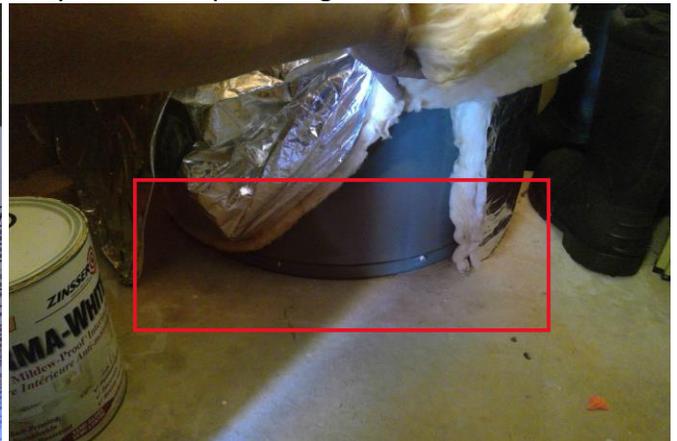
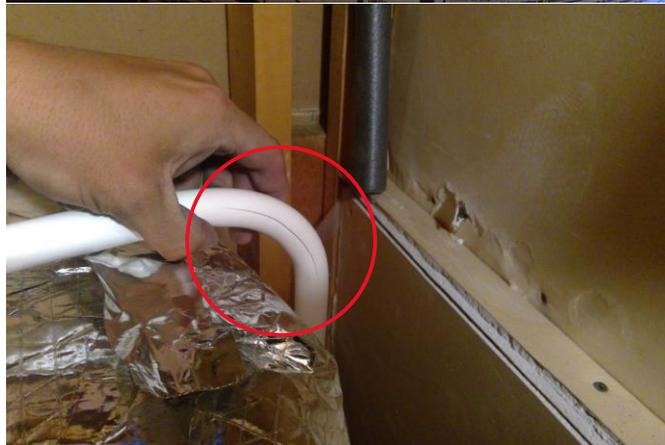
C. Water Heating Equipment

Comments: A pan was not installed under water heater. This may lead to corrosion and shortened lifespan of water heater. The water heater also had a crack in the TPS discharge pipe. Both deficiencies should be corrected by a licensed plumbing contractor.

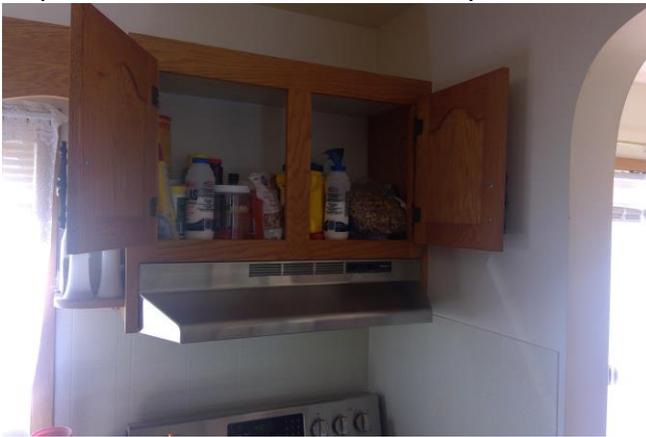
C. Range Hood and Exhaust System

Comments: Range hood doesn't vent outside. This condition is substandard and may result in the accumulation of smoke and moisture in the home while cooking. Inspector recommends correction by licensed contractor.
