OSPREY HOME INSPECTIONS

Inspection Report

155 Sample Street, Halifax A1B 2C3

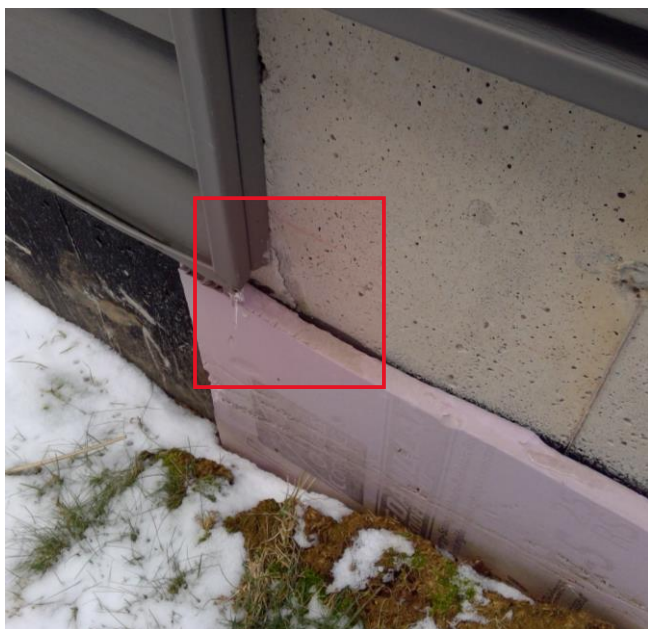
A. Foundation

Comments: On the day of the inspection, inspector observed a small hairline crack on Southeast side of home (opposite side of gate). Doesn't appear to allow water to intrude, however this condition should be monitored for widening of crack and water intrusion.

A. *(Monitor)* On the day of the inspection, inspector observed a small hairline crack on Southeast side of home (opposite side of gate). Doesn't appear to allow water to intrude, however this condition should be monitored for widening of crack and water intrusion.

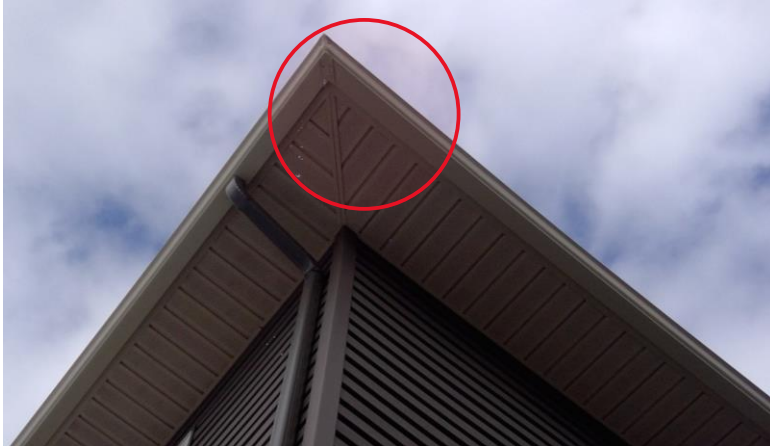
B. Grading and Drainage

Comments: At the time of the inspection, the inspector observed water dripping from the south corner of the gutter. Inspector recommends more sealant to be applied to the corner of gutter when weather conditions allow for proper bond.

B. *(Repair/Replace)* At the time of the inspection, the inspector observed water dripping from the south corner of the gutter. Inspector recommends more sealant to be applied to the corner of gutter when weather conditions allow for proper bond.

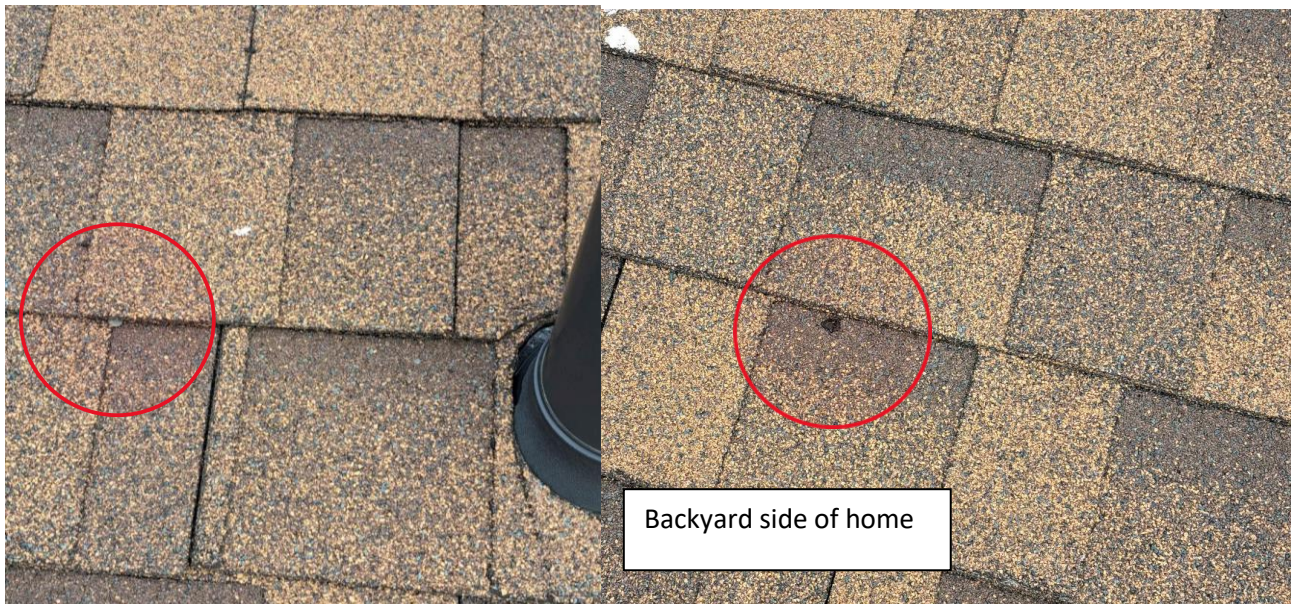
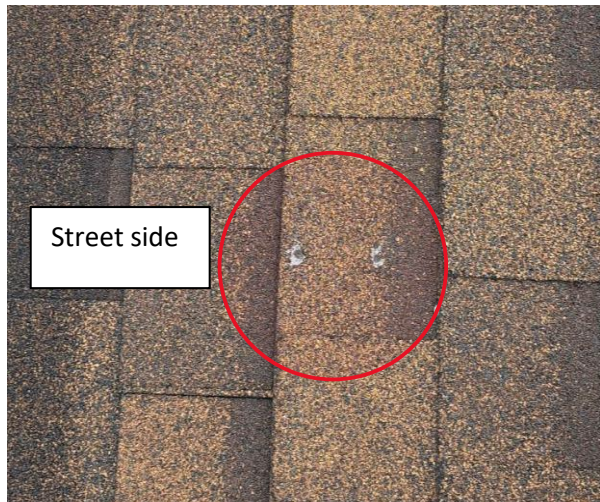
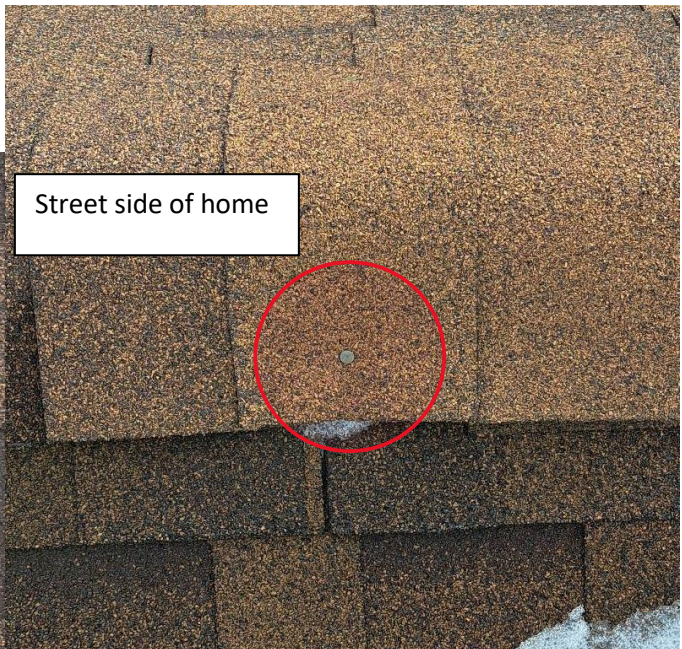
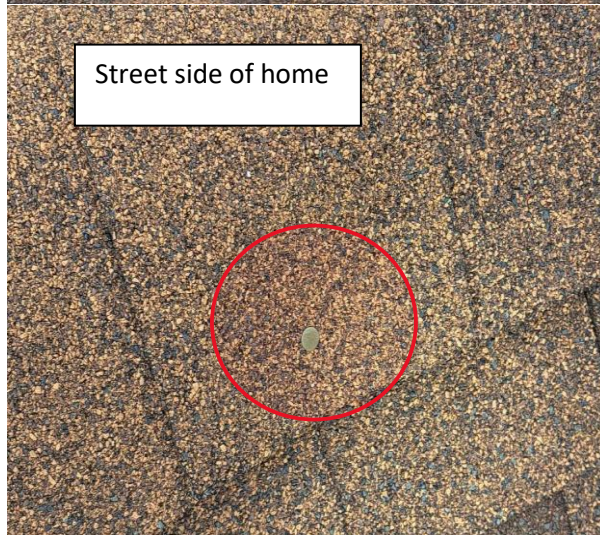
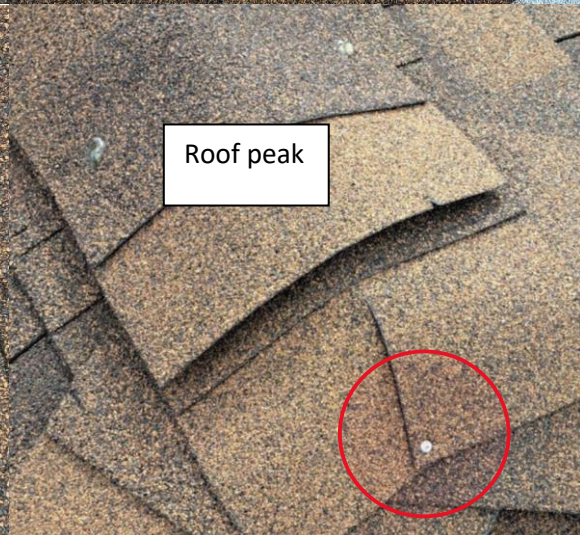
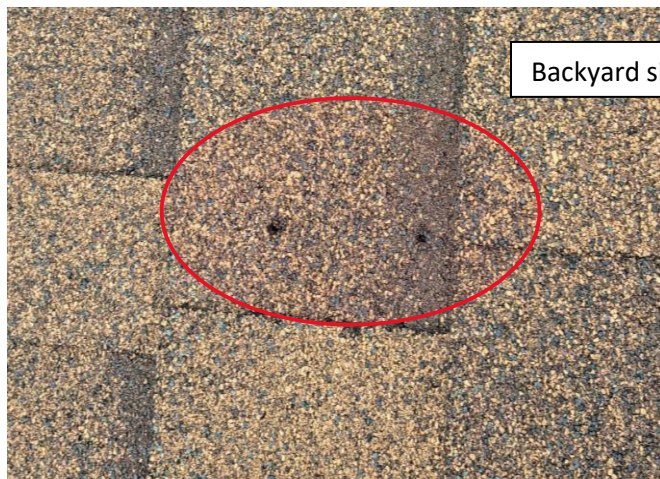
C. Roof Covering Materials

Comments: At the time of inspection, the inspector observed many exposed and partially exposed nails and nail holes. Although there was no evidence of water intrusion in the attic, if left this condition may lead to water intrusion into the attic space. Inspector recommends repair by licensed roofing contractor.

C. *(Repair/Replace)* At the time of inspection, the inspector observed many exposed and partially exposed nails and nail holes. Although there was no evidence of water intrusion in the attic, if left this condition may lead to water intrusion into the attic space. Inspector recommends repair by licensed roofing contractor.

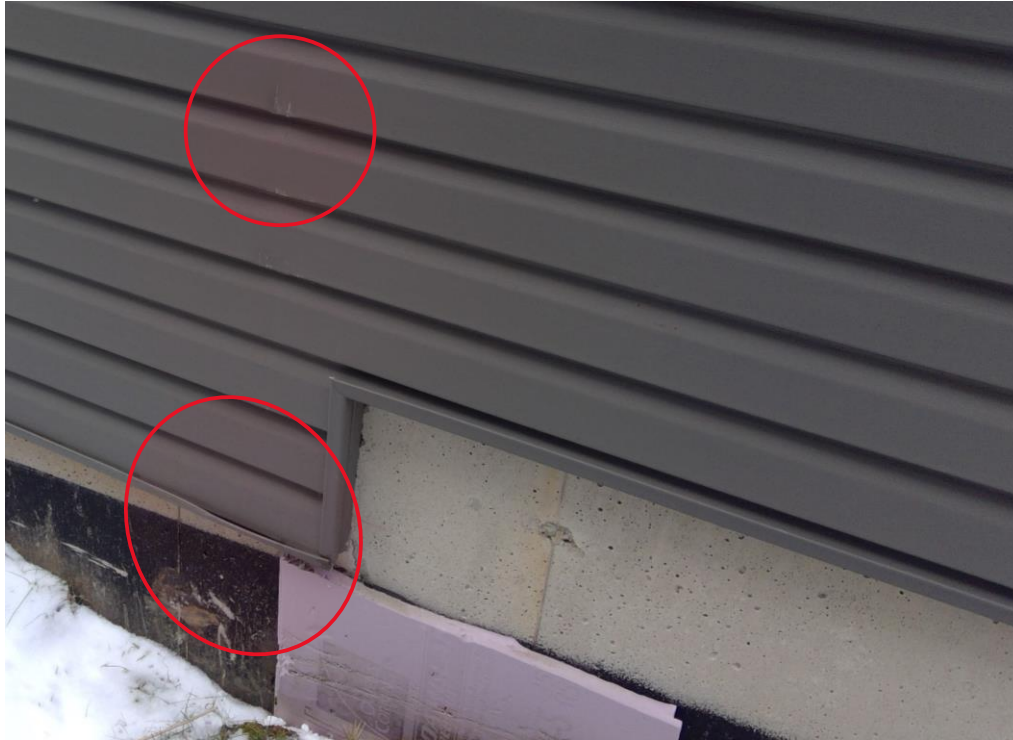
E. Walls (Exterior and Interior)

Comments: At the time of the inspection, the inspector observed loose J-Trim on southeast side of home as well as some damaged siding. This condition does not affect the structure of the home; however, the inspector recommends fastening of the J-Trim to avoid further damage from wind.

E. *(Repair/Replace)* At the time of the inspection, the inspector observed loose J-Trim on southeast side of home as well as some damaged siding. This condition does not affect the structure of the home; however, the inspector recommends fastening of the J-Trim to avoid further damage from wind.

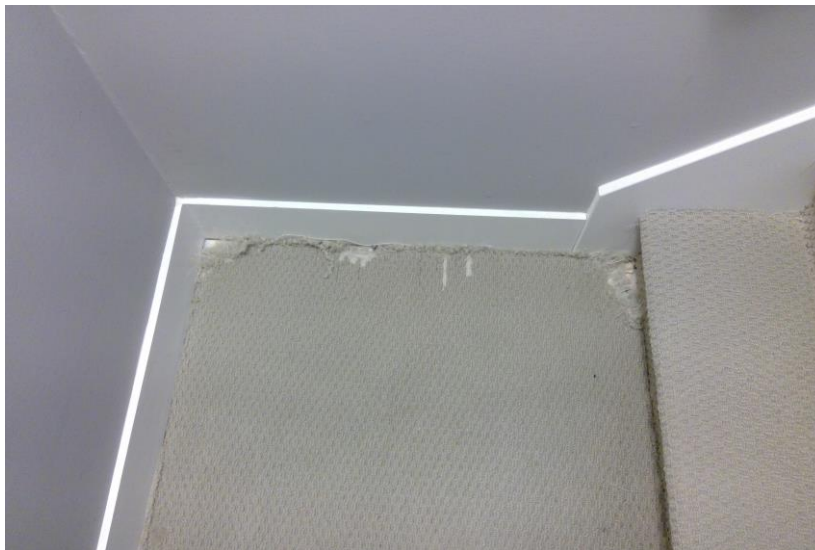
☒
☐
☐
☐
☐
 F. Ceiling and Floors

Comments: Various drywall patches/fixes throughout home, this does not fall within the scope of the home inspection, as this condition is cosmetic, and doesn't indicate damage. At the time of the inspection, the inspector observed damaged carpeting on basement stair landing. Inspector recommends replacement of carpeting at this location by licensed flooring contractor.

F. *(Repair/Replace)* At the time of the inspection, the inspector observed damaged carpeting on basement stair landing. Inspector recommends replacement of carpeting at this location by licensed flooring contractor.

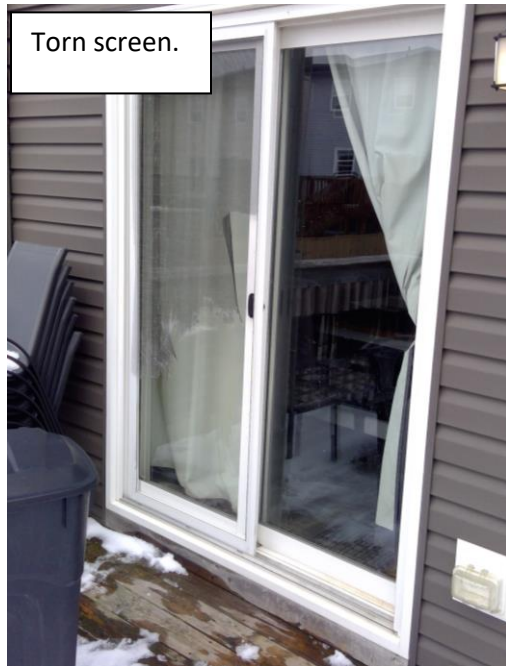
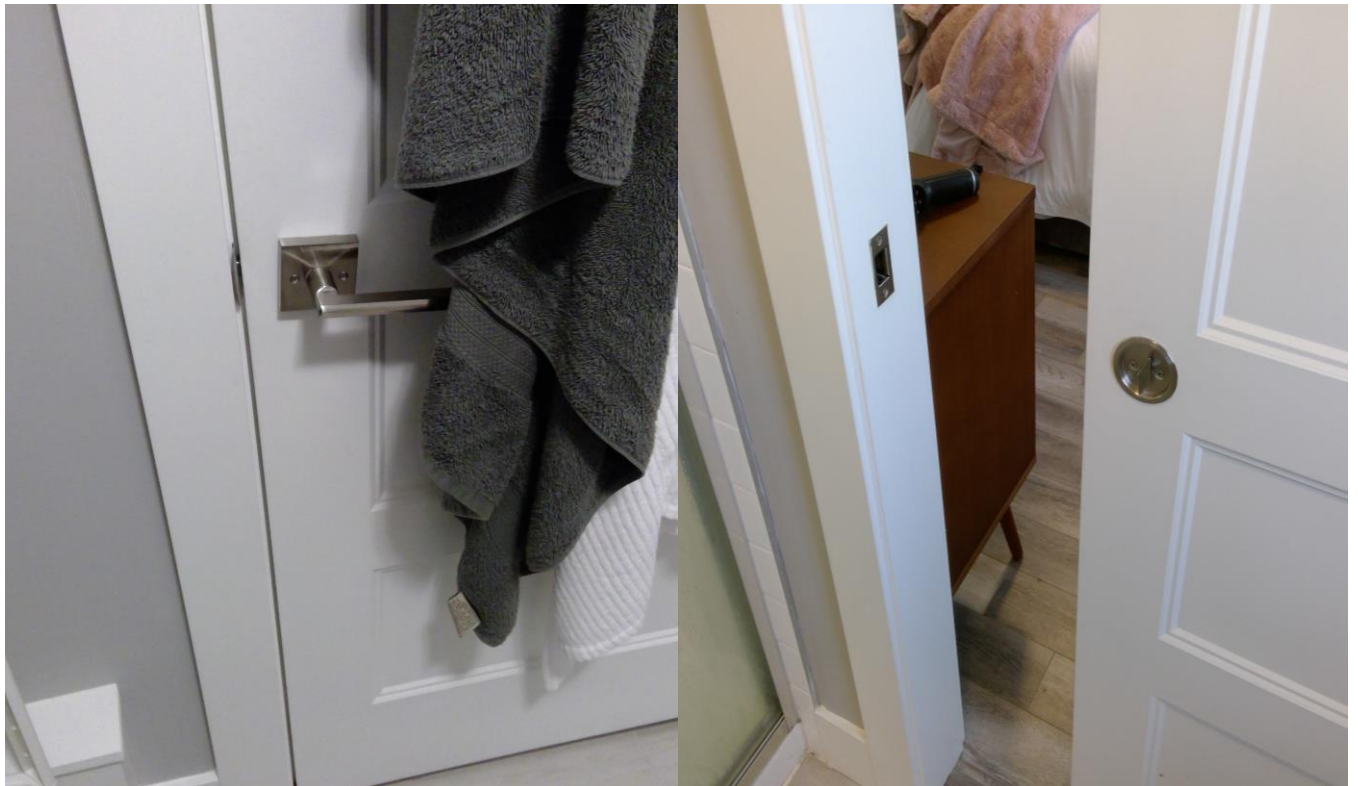
☒
☐
☐
☐
☐
 G. Doors

Comments: The bathroom on basement level, and the en-suite bathroom didn't have an operable lock installed. This condition doesn't fall within scope of home inspection, although for the interest of privacy, inspector recommends installation of lock on both doors. Also at the time of inspection, the inspector observed torn/missing screening on patio door. Inspector recommends repair of screen by competent person.

G. *(Repair/Replace)* The bathroom on basement level, and the en-suite bathroom didn't have an operable lock installed. This condition doesn't fall within scope of home inspection, although for the interest of privacy, inspector recommends installation of lock on both doors. Also at the time of inspection, the inspector observed torn/missing screening on patio door. Inspector recommends repair of screen by competent person.

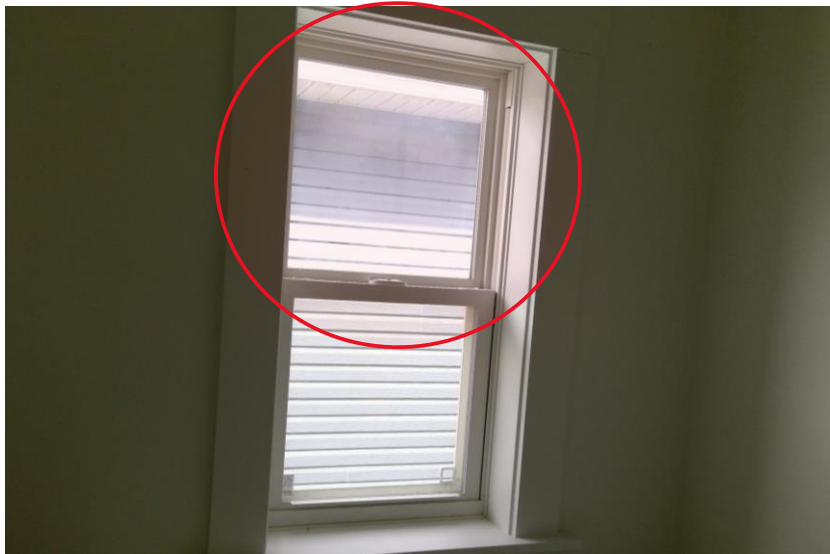
H. Windows

Comments: At the time of the inspection, the inspector observed fogging between the panes of glass of the laundry room window, indicating the seals have failed. Inspector recommends further evaluation and repair by licensed window contractor.

H. *(Repair/Replace)* At the time of the inspection, the inspector observed fogging between the panes of glass of the laundry room window, indicating the seals have failed. Inspector recommends further evaluation and repair by licensed window contractor.

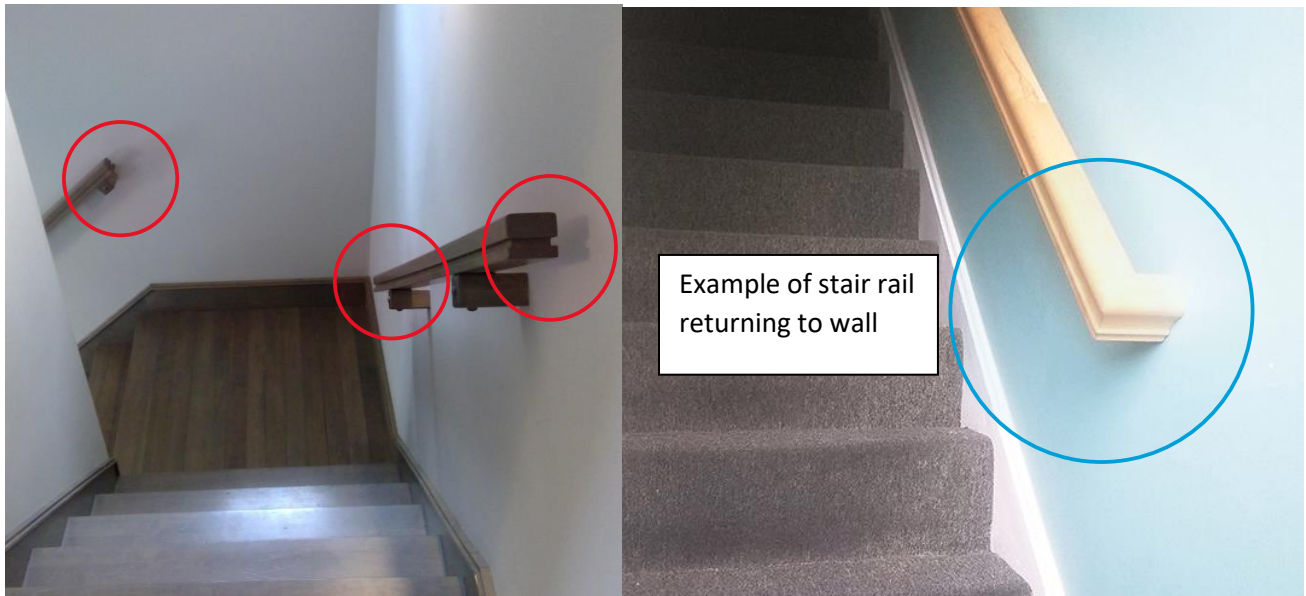
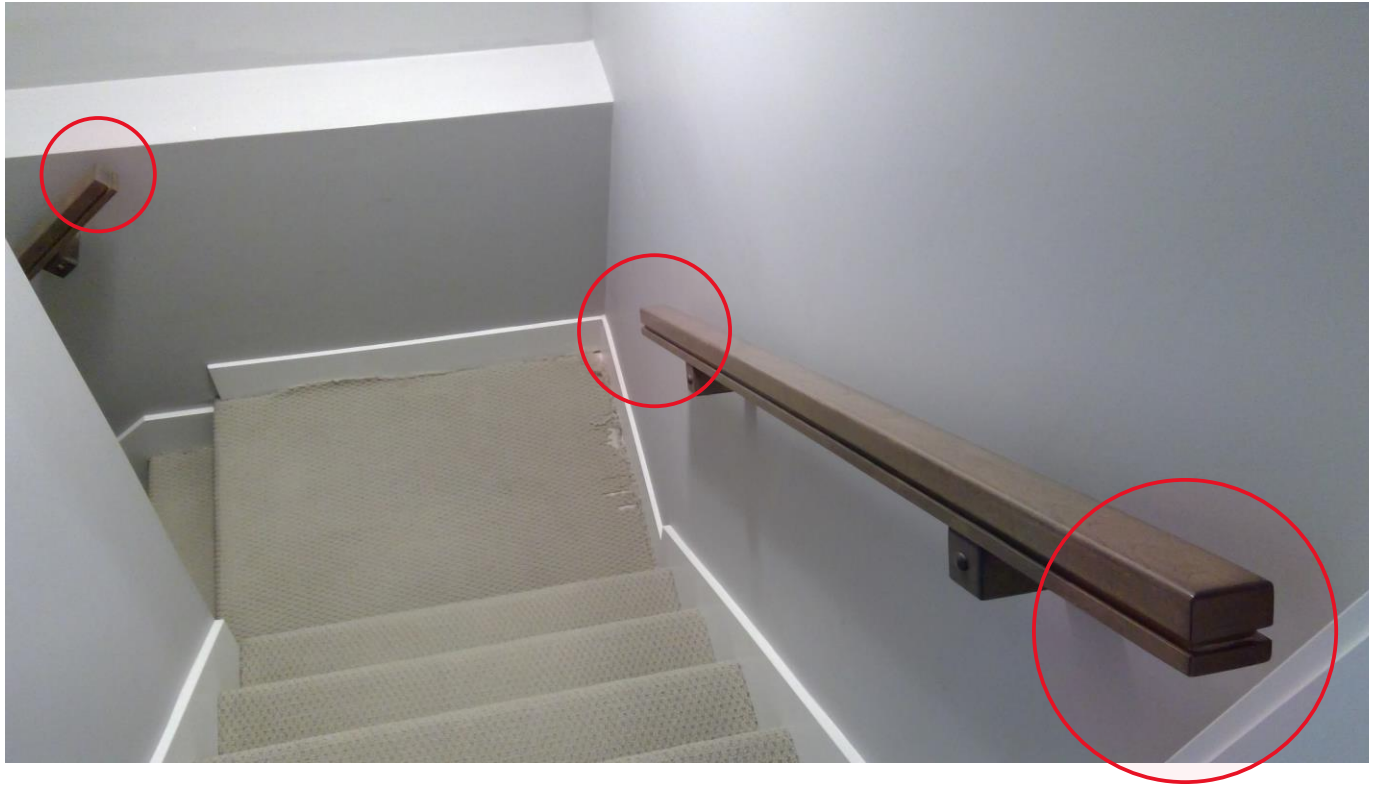
I. Stairways (interior and Exterior)

Comments: At the time of the inspection, the inspector observed the interior handrails didn't return to the wall. This condition poses a possibility of snagging clothing leading to a fall. Inspector recommends replacement of rail by licensed contractor.

I. *(Repair/Replace)* At the time of the inspection, the inspector observed the interior handrails didn't return to the wall. This condition poses a possibility of snagging clothing leading to a fall. Inspector recommends replacement of rail by licensed contractor.

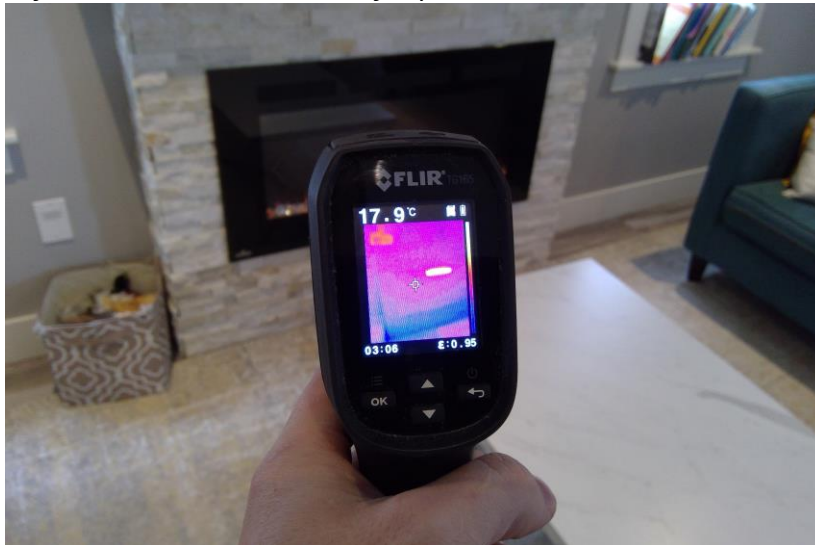
Comments: At the time of the inspection, the inspector didn't observe any deficiencies with the electric fireplace.

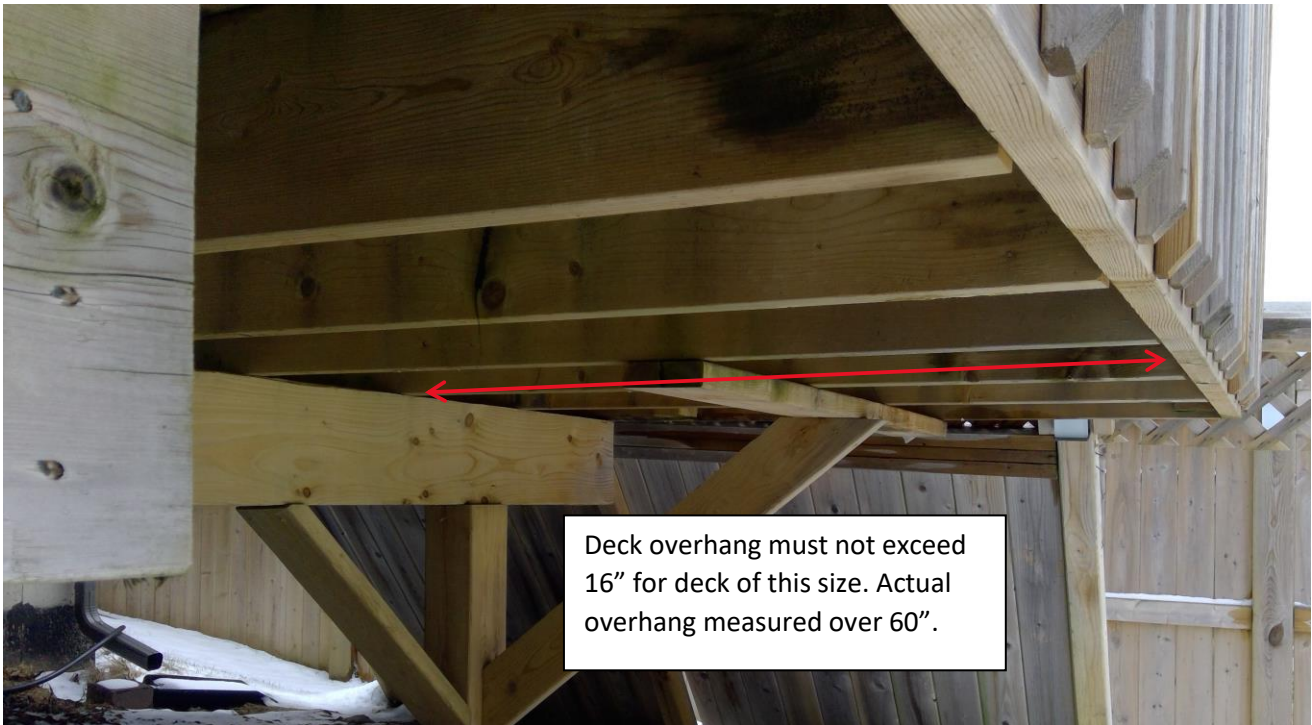
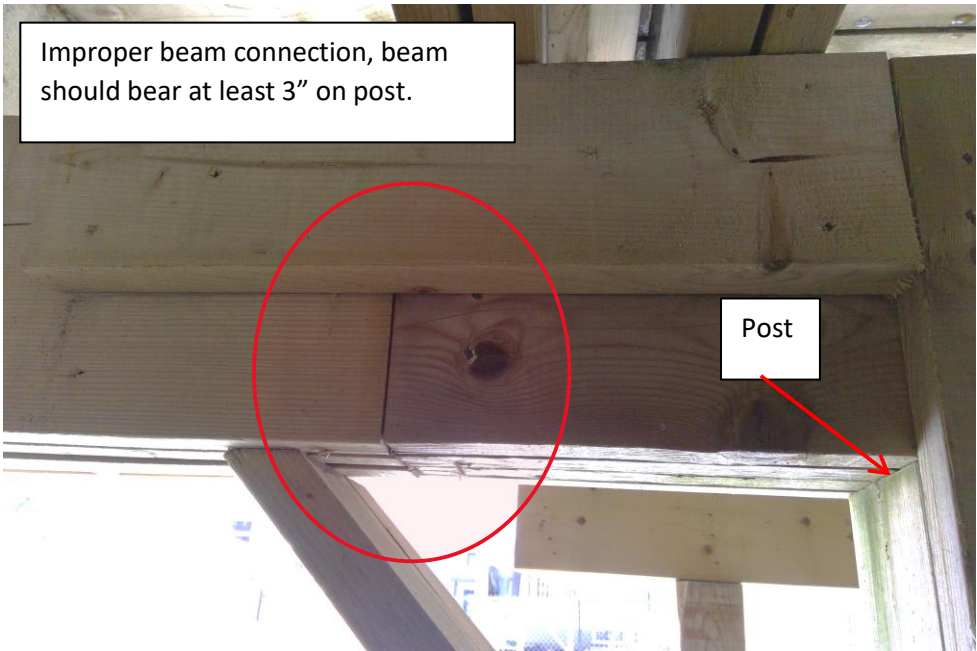
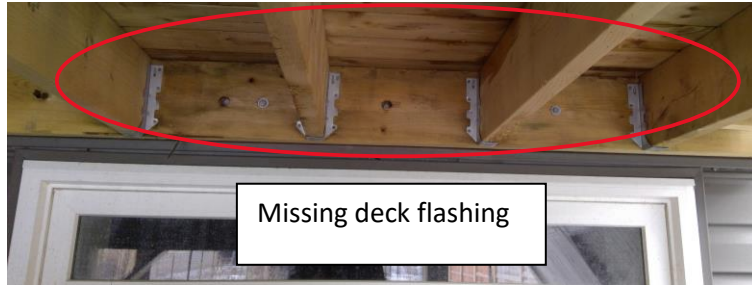
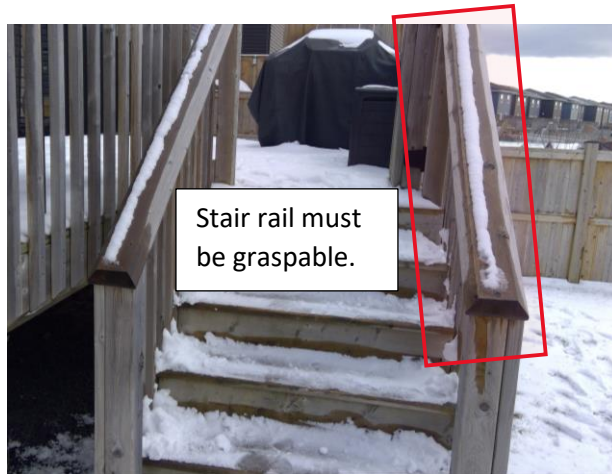
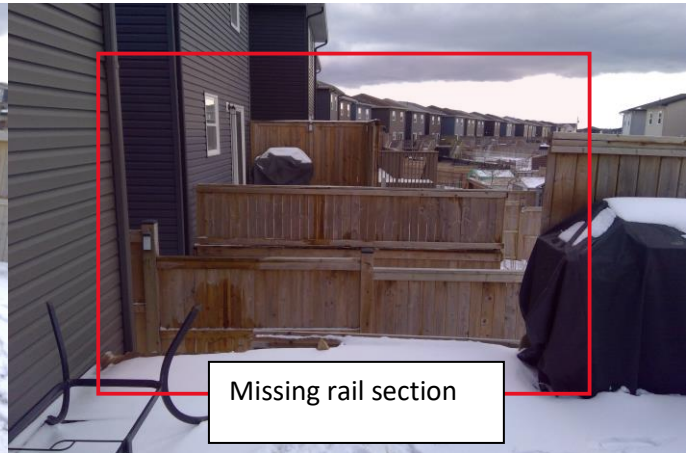
K. Balconies, Decks, Porches, Carports

Comments: At the time of the inspection the inspector observed many substandard conditions in relation to the backyard deck. These include over spanning of deck overhang,

Improper bearing of beam, missing drip flashing at house connection, ungraspable stair rails, and missing portion of rail. The inspector recommends repairing of all items by licensed contractor.

K. *(Safety Issue)* At the time of the inspection the inspector observed many substandard conditions in relation to the backyard deck. These include over spanning of deck overhang, Improper bearing of beam, missing drip flashing at house connection, ungraspable stair rails, and missing portion of rail. The inspector recommends repairing of all items by licensed contractor.

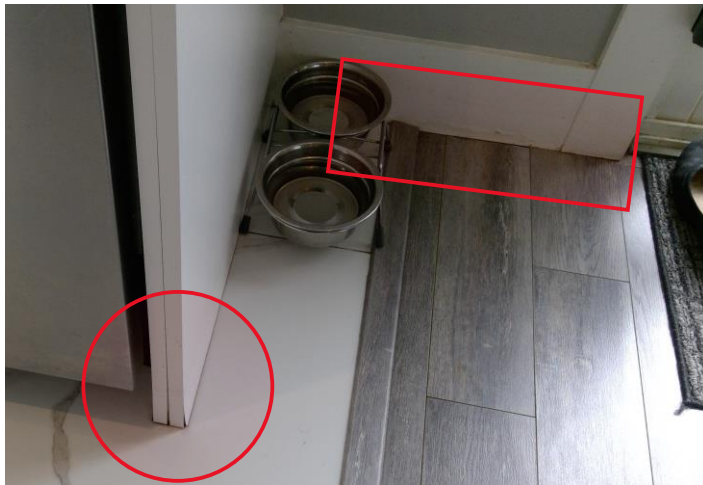
☒
☐
☐
☐
☐
 L. Other

Comments: At the time of the inspection, the inspector observed the baseboard and gable end of cabinet was water damaged and delaminating, this condition is unsightly and should be further evaluated and repaired by licensed contractor.

L. *(Repair/Replace)* At the time of the inspection, the inspector observed the baseboard and gable end of cabinet was water damaged and delaminating, this condition is unsightly and should be further evaluated and repaired by licensed contractor.

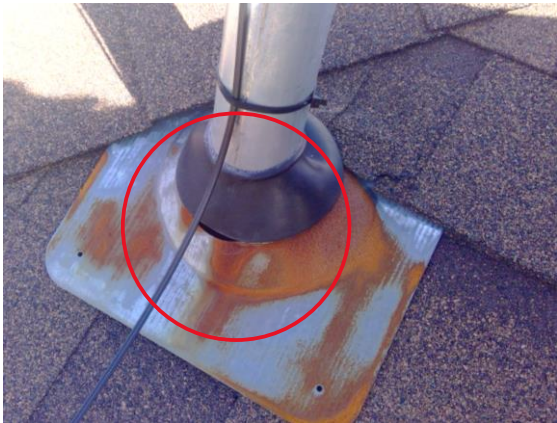
A. Service Entrance and Panels

Comments: At the time of the inspection, the inspector observed a rubber gasket that failed to cover the rain boot appropriately. This condition will allow rain to enter the home, and may cause damage to structural components, service panel, and the effectiveness of the attic insulation. Inspector recommends further evaluation and repair by licensed roofing contractor.

A. *(Repair/Replace)* At the time of the inspection, the inspector observed a rubber gasket that failed to cover the rain boot appropriately. This condition will allow rain to enter the home, and may cause damage to structural components, service panel, and the effectiveness of the attic insulation. Inspector recommends further evaluation and repair by licensed roofing contractor.

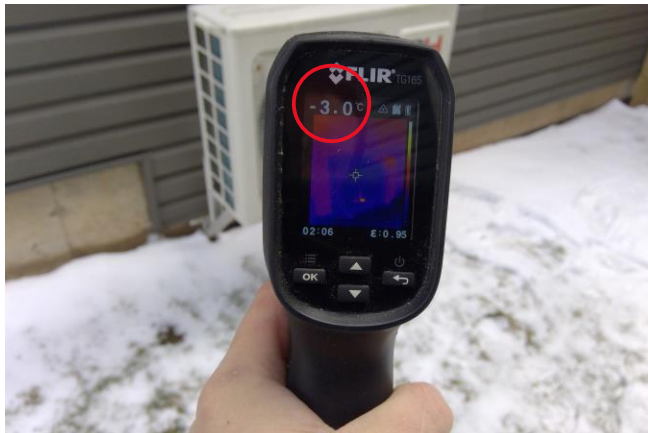
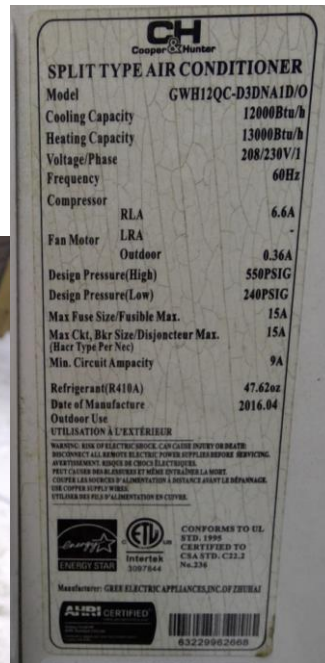
Comments: At the time of the inspection, air conditioning function could not be tested due to outside temperatures being less than 15 degrees Celsius.

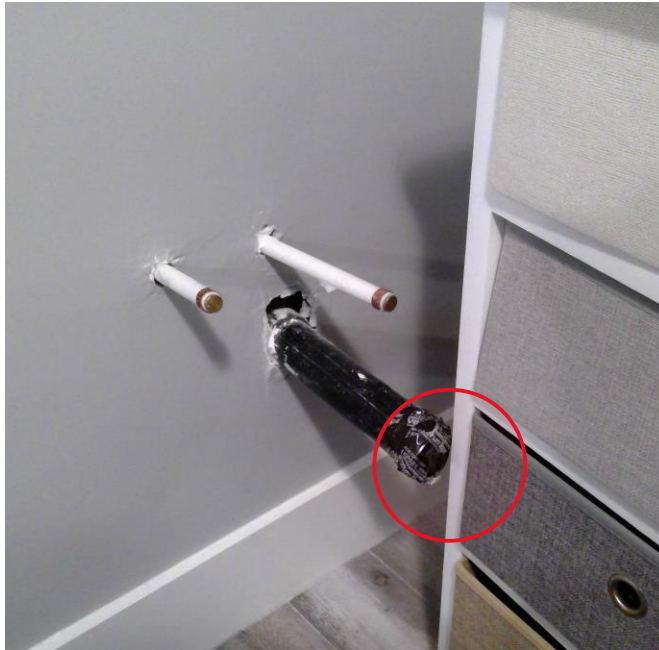
B. Drains, Wastes, and Vents

Comments: At the time of inspection, inspector observed improper capping of drainpipe in basement. This condition may allow hazardous gases to enter living space. Inspector also observed degraded caulking on en-suite shower. This condition may allow water to escape shower, leading to water damage or microbial growth. Inspector recommends all items to be corrected by licensed plumbing contractor.

Degraded caulking at joint between shower pan and door slide.

B. *(Repair/Replace)* At the time of inspection, inspector observed improper capping of drainpipe in basement. This condition may allow hazardous gases to enter living space. Inspector also observed degraded caulking on en-suite shower. This condition may allow water to escape shower, leading to water damage or microbial growth. Inspector recommends all items to be corrected by licensed plumbing contractor.

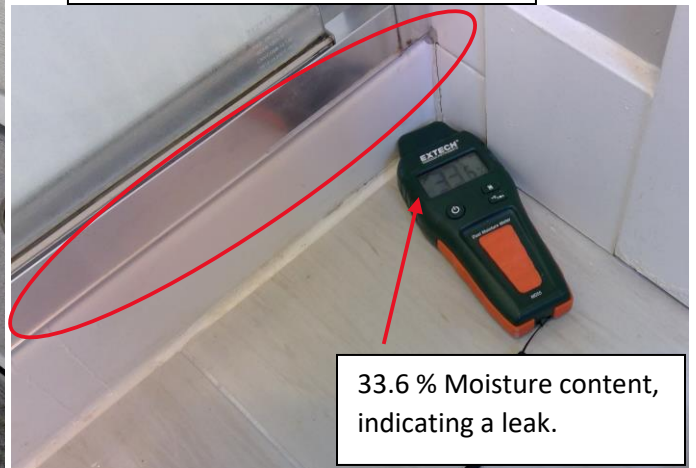
33.6 % Moisture content, indicating a leak.

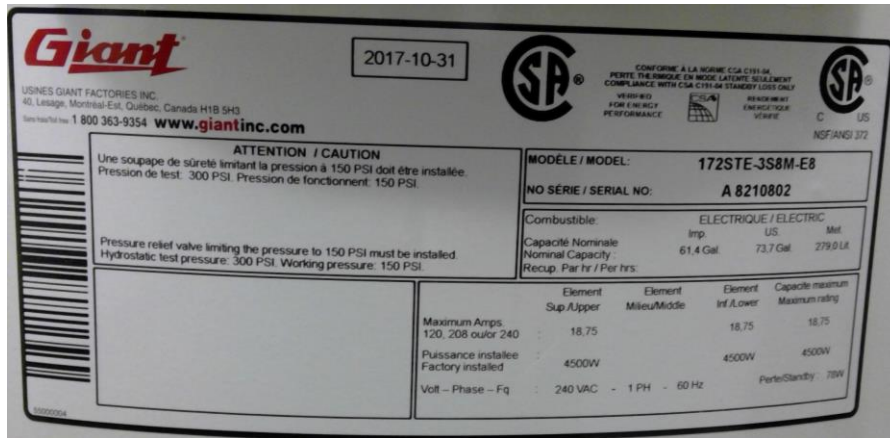
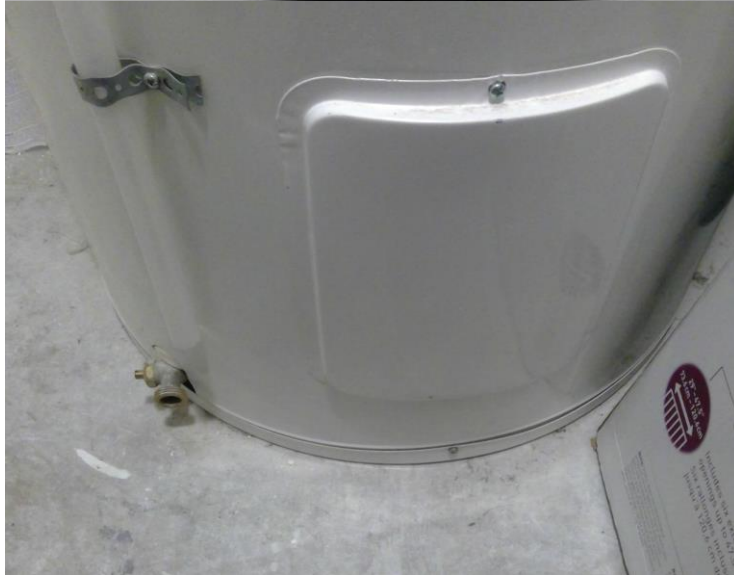
C. Water Heating Equipment

Comments: At the time of the inspection, the inspector observed the water heater was installed on concrete slab without the use of a drip pan, this condition may lead to rust to develop, shortening the lifespan of the water heater. Inspector recommends drip pan to be placed under water heater by licensed plumbing contractor.

C. *(Repair/Replace)* At the time of the inspection, the inspector observed the water heater was installed on concrete slab without the use of a drip pan, this condition may lead to rust to develop, shortening the lifespan of the water heater. Inspector recommends drip pan to be placed under water heater by licensed plumbing contractor

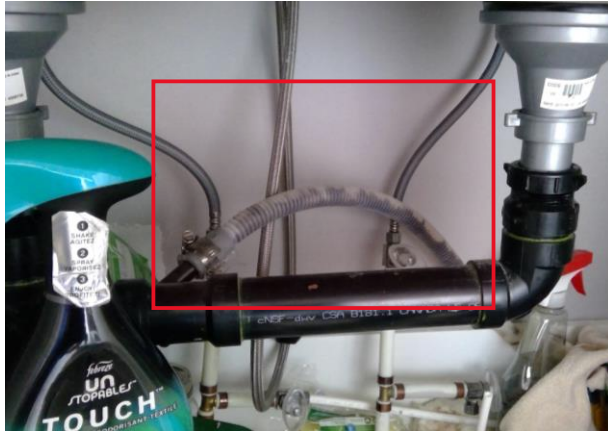
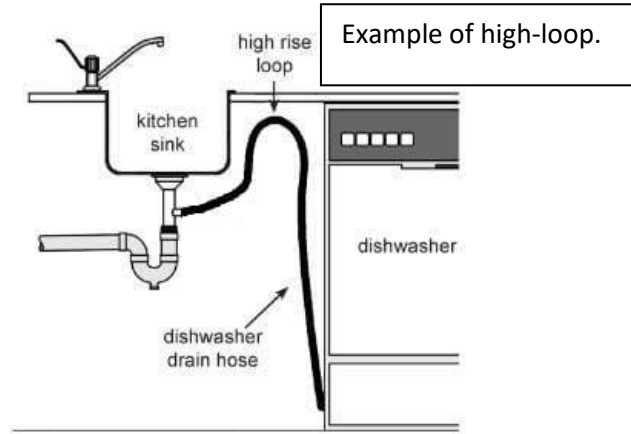
A. Dishwasher

Comments: At the time of the inspection, the inspector observed the lack of a high-loop in regards to the drain hose for dishwasher. This condition may lead to cross-contamination in the event of a blockage in P-Trap. Inspector recommends a high-loop to be installed by competent person.

A. *(Repair/Replace)* At the time of the inspection, the inspector observed the lack of a high-loop regarding the drain hose for dishwasher. This condition may lead to cross-contamination in the event of a blockage in P-Trap. Inspector recommends a high-loop to be installed by competent person.

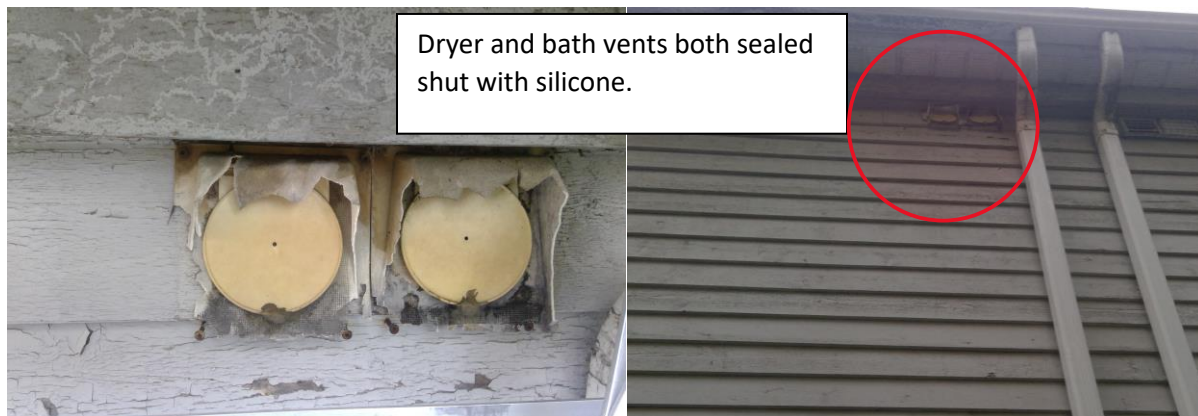
F. Mechanical Exhaust Vents and Bathroom Heaters

Comments: At the time of the inspection, the inspector observed the dryer and bathroom vents were sealed shut with silicone (for dryer vent see 5H). This condition greatly affects the efficiency and may cause premature failure of the bath vent. This condition will also allow moisture to build up inside the home, promoting the growth of microbial growth, affecting indoor air quality. Inspector recommends removal of silicone or replacement of vent cover.

F. *(Repair/Replace)* At the time of the inspection, the inspector observed the dryer and bathroom vents were sealed shut with silicone (for dryer vent see 5H). This condition greatly affects the efficiency and may cause premature failure of the bath vent. This condition will also allow moisture to build up inside the home, promoting the growth of microbial growth, affecting indoor air quality. Inspector recommends removal of silicone or replacement of vent cover.

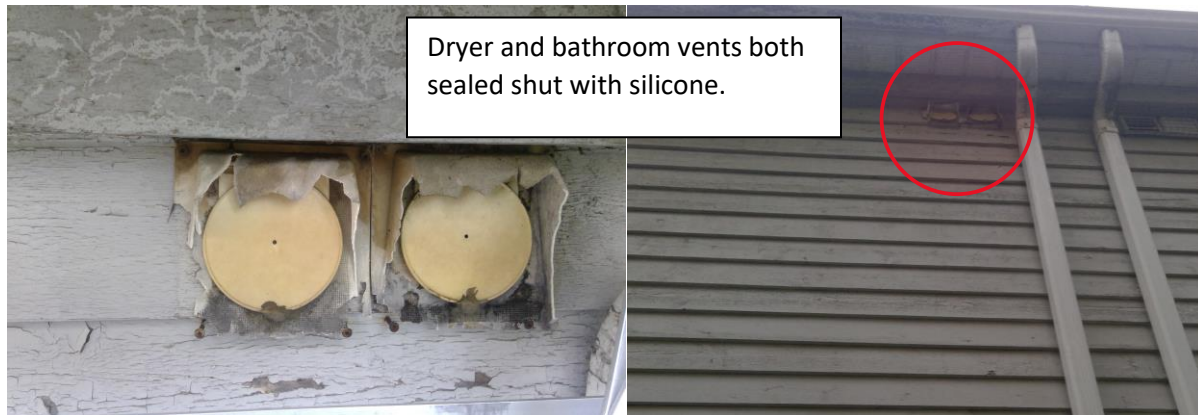
H. Dryer Exhaust Systems

Comments: At the time of the inspection, the inspector observed the dryer and bathroom vents were sealed shut with silicone (for bath vent see 5F). This condition causes the dryer to work substantially harder and may cause premature failure of appliance. This will also

cause lint to build up inside the dryer hose leading to a potential fire. Inspector recommends removal of silicone sealant or replacement of vent cover by a competent person.

H. *(Safety Issue)* At the time of the inspection, the inspector observed the dryer and bathroom vents were sealed shut with silicone (for bath vent see 5F). This condition causes the dryer to work substantially harder and may cause premature failure of appliance. This will also cause lint to build up inside the dryer hose leading to a potential fire. Inspector recommends removal of silicone sealant or replacement of vent cover by a competent person.
